**MONITORING RESULTS FROM THE FIELD PILOT STUDY
OF IN SITU CAPPING OF PALOS VERDES SHELF
CONTAMINATED SEDIMENTS
(Part 2 of 2)**

July 2002

Science Applications International Corporation
Admiral's Gate
221 Third Street
Newport, RI 02840
SAIC Report Number 514

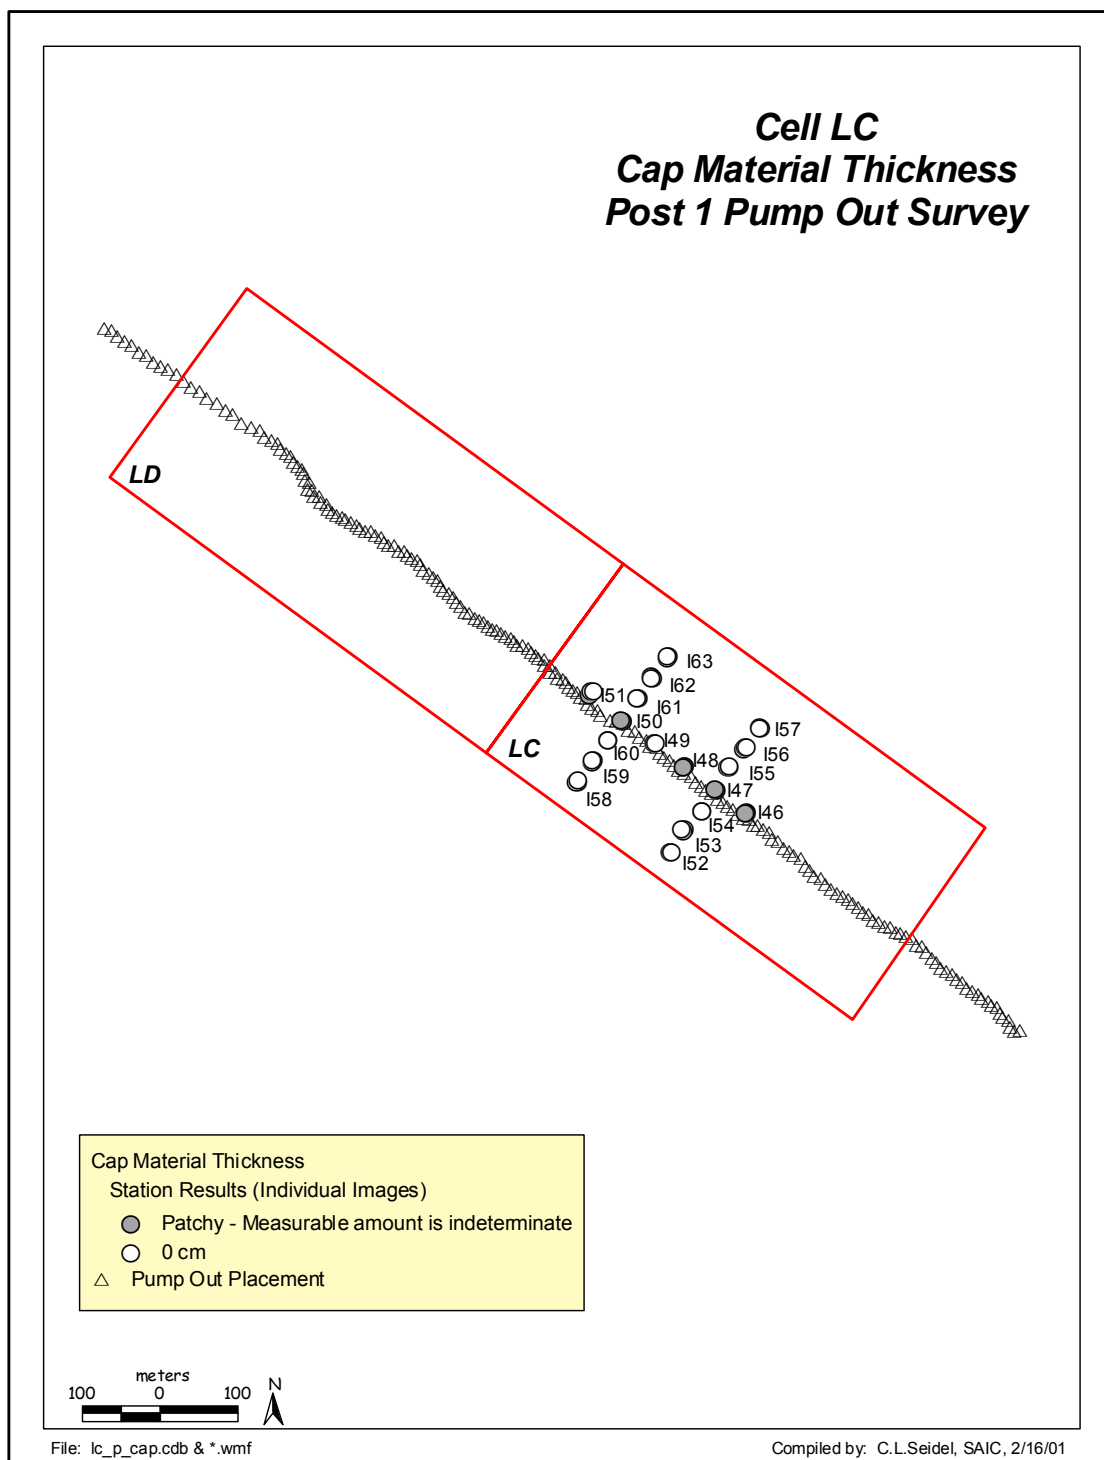
Figure 6.5-2. Track line of the hopper dredge during the pump-out placement event in Cell LC, and thickness of the resultant cap layer in replicate images obtained at each station.

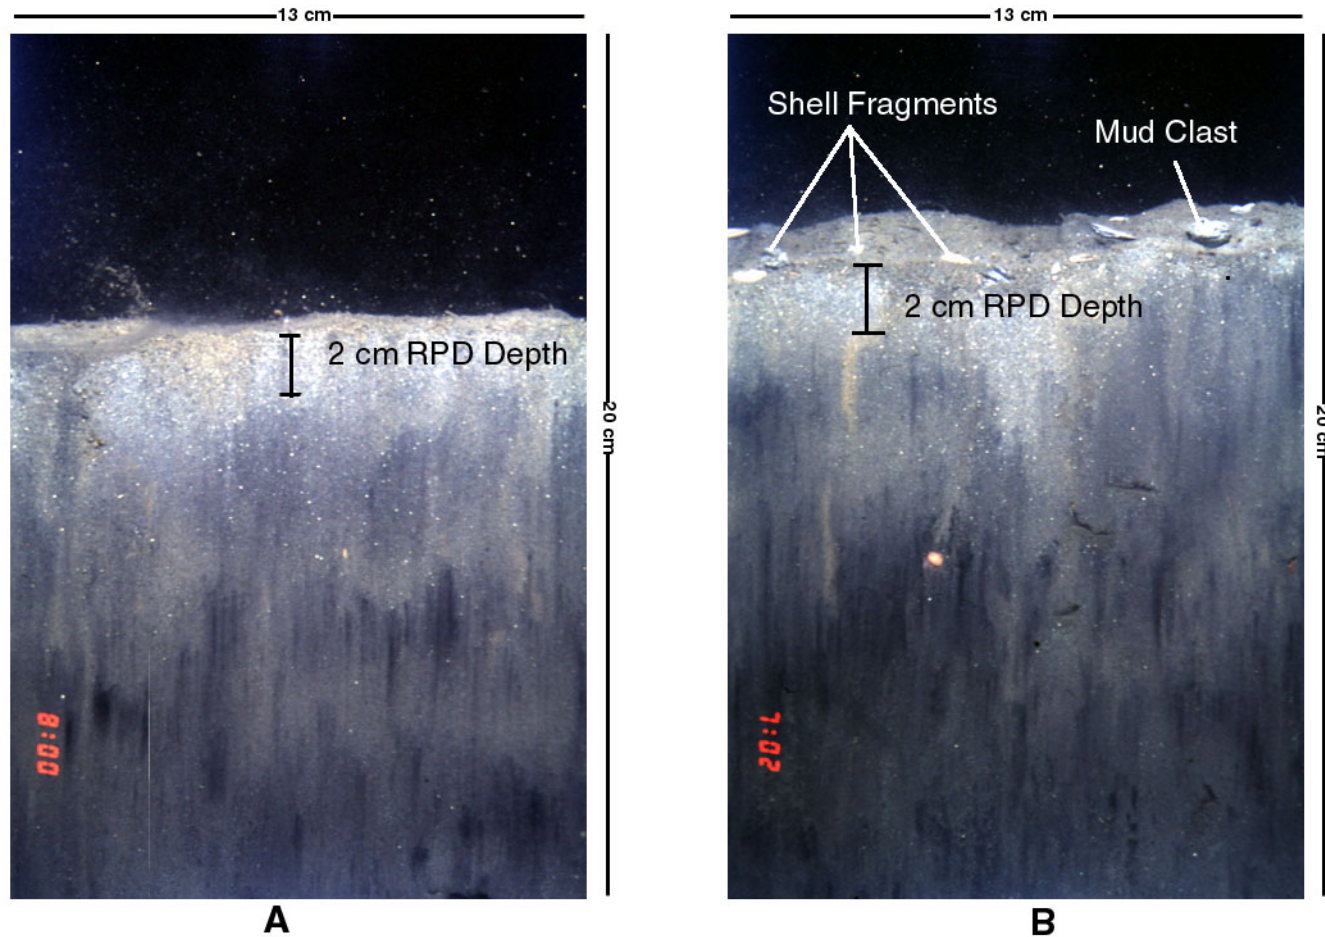
Figure 6.5-3. Two sediment profile images from Cell LC station I47. Image A from the baseline survey shows existing EA sediment consisting of sandy mud, with an RPD depth of 2.0 cm. Image B from the post 1 pump out survey shows the same EA sediment, with several shell fragments and gray mud clasts at the surface, providing evidence of the presence of Queen's Gate cap material.

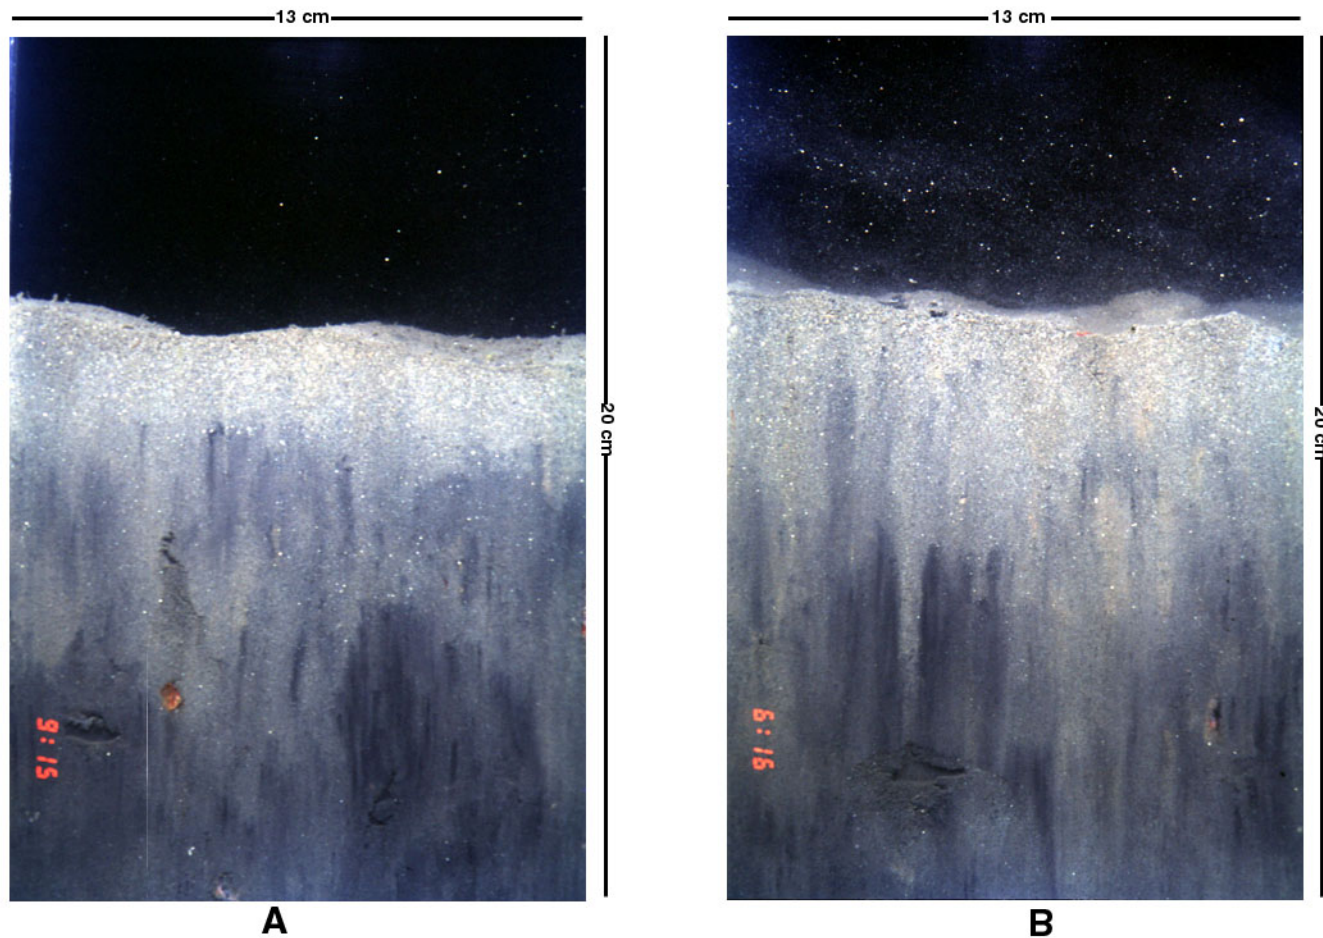
Figure 6.5-4. Two sediment profile images from Cell LC station I61 showing the similarity in sediment conditions before (Image A) and after (Image B) the Post 1 pump out placement event. In both images, surface sediment consists of sandy mud with a well-developed RPD. Note the absence of any distinct surface depositional layers of cap material in image B.

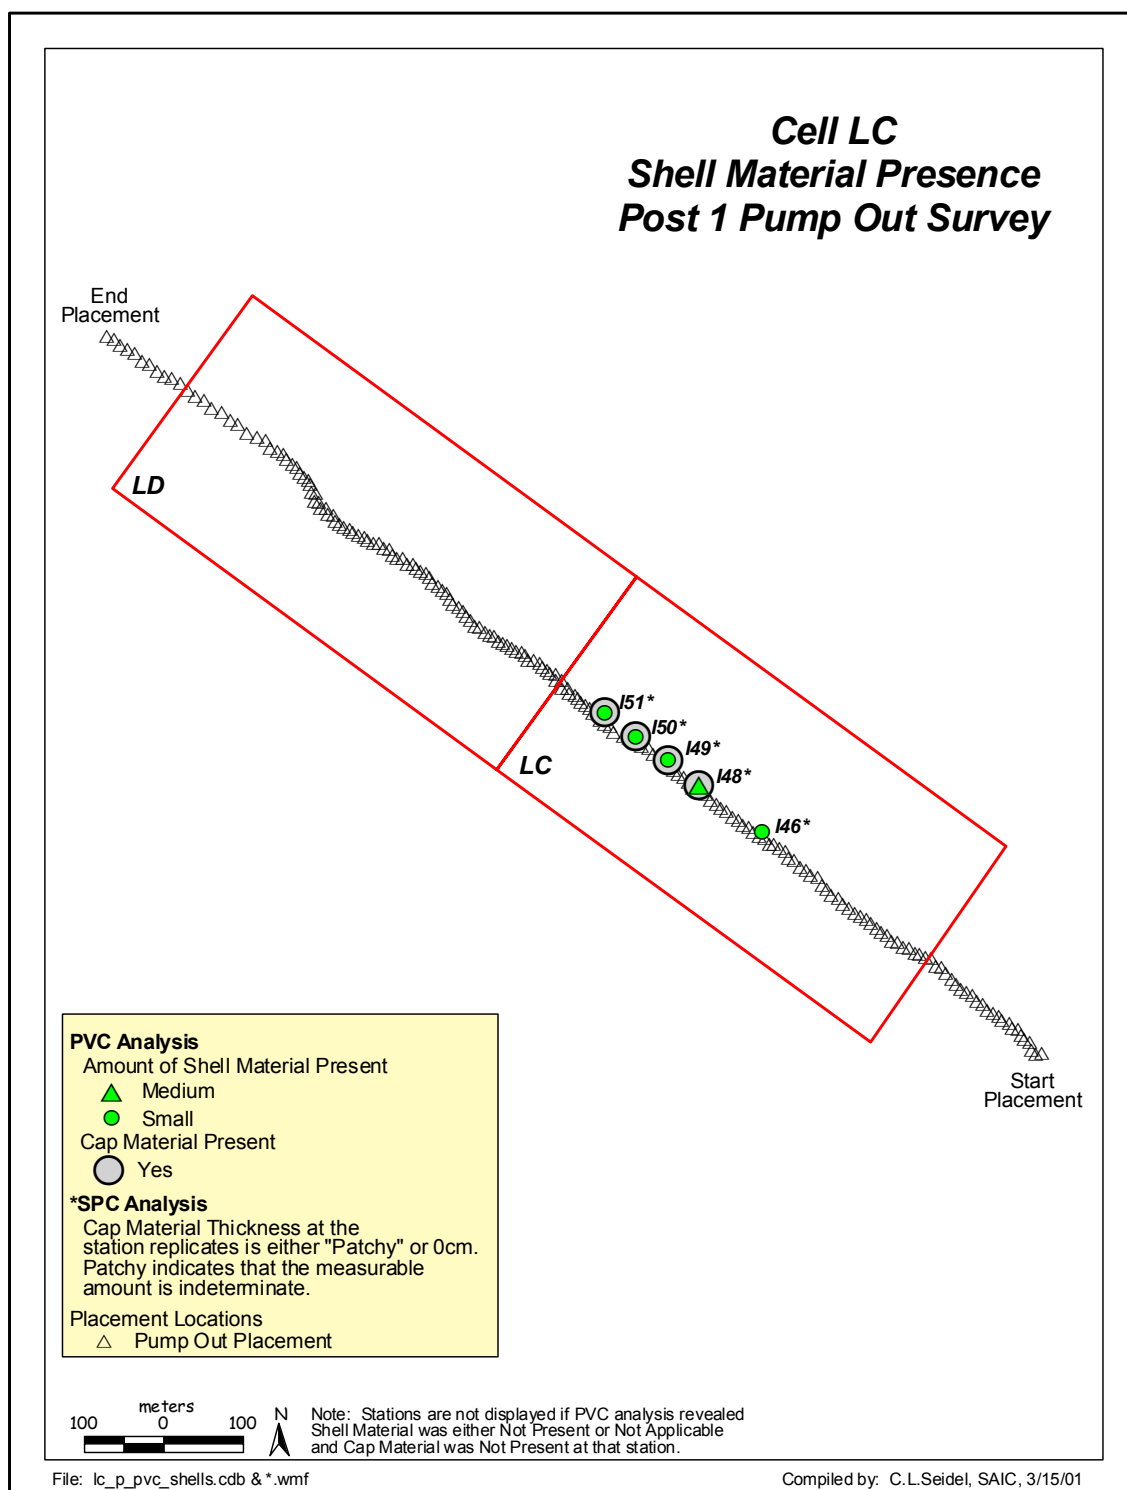
Figure 6.6-2. Lateral extent of cap material based on plan view image (PVI) analysis – Post 1 supplemental survey.

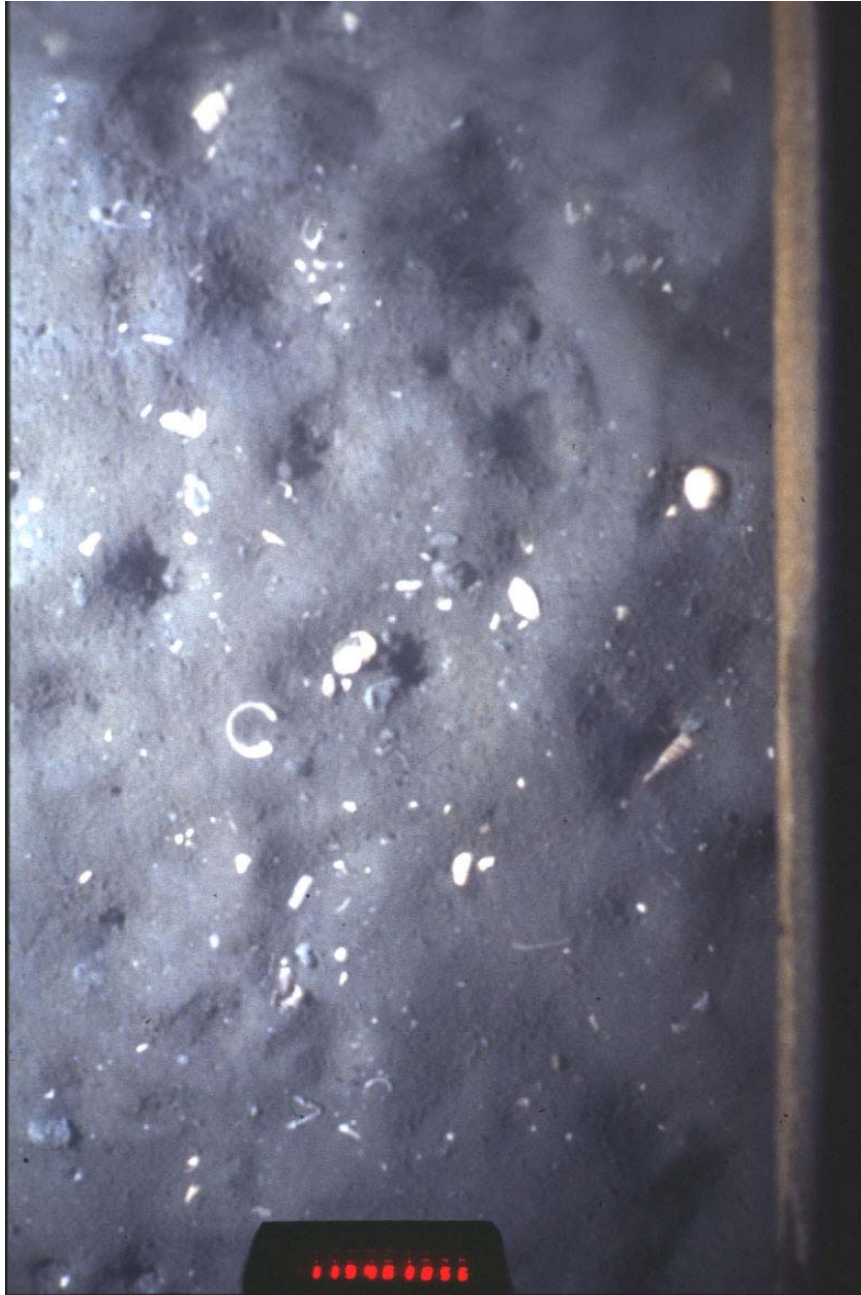
Figure 6.6-3. Cap Material Presence in Cell LC. This image acquired at inside station I48 during the Post 1 Pump Out plan view survey provides evidence of the presence of cap material within the cell in terms of the color contrast between sediments and through the presence of shell material. The image appears to contain patches of lighter gray material and darker gray material, suggesting that this station received a trace amount of cap material coverage. Shell material, the apparent presence of filled burrows and small clay clasts throughout the image also support the presence of cap material.

Stations that appeared to have cap material present include Stations I48-51 (Figure 6.6-2). Station I50 appeared to be completely covered. These results are based on what appeared to be cap filled burrows.

Shell material could be seen in Stations I48-51 as well (Figure 6.6-3). The amount of shell material was primarily a small to medium amount.

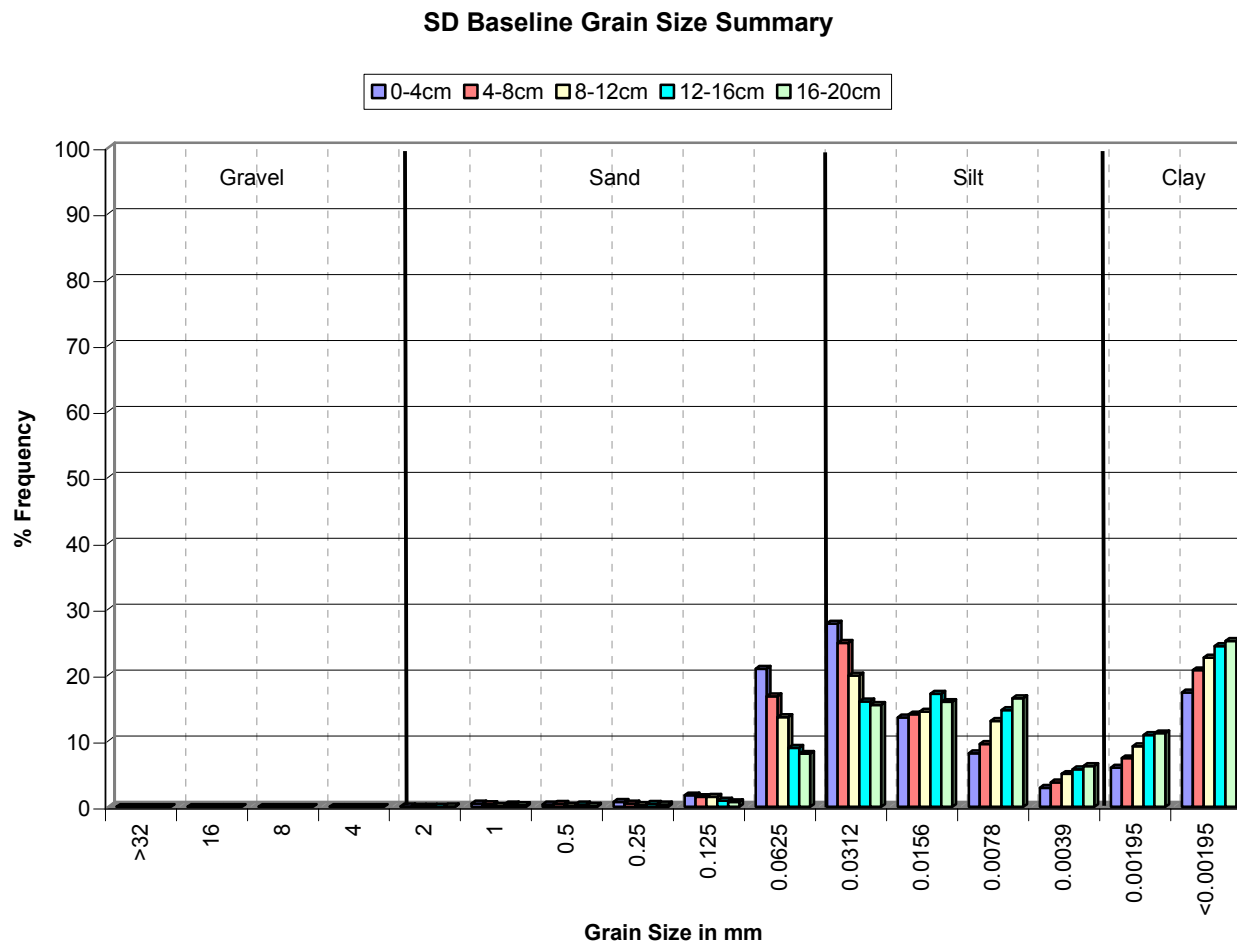
Figure 7.2-2. Grain size distributions of Cell SD baseline sediments.

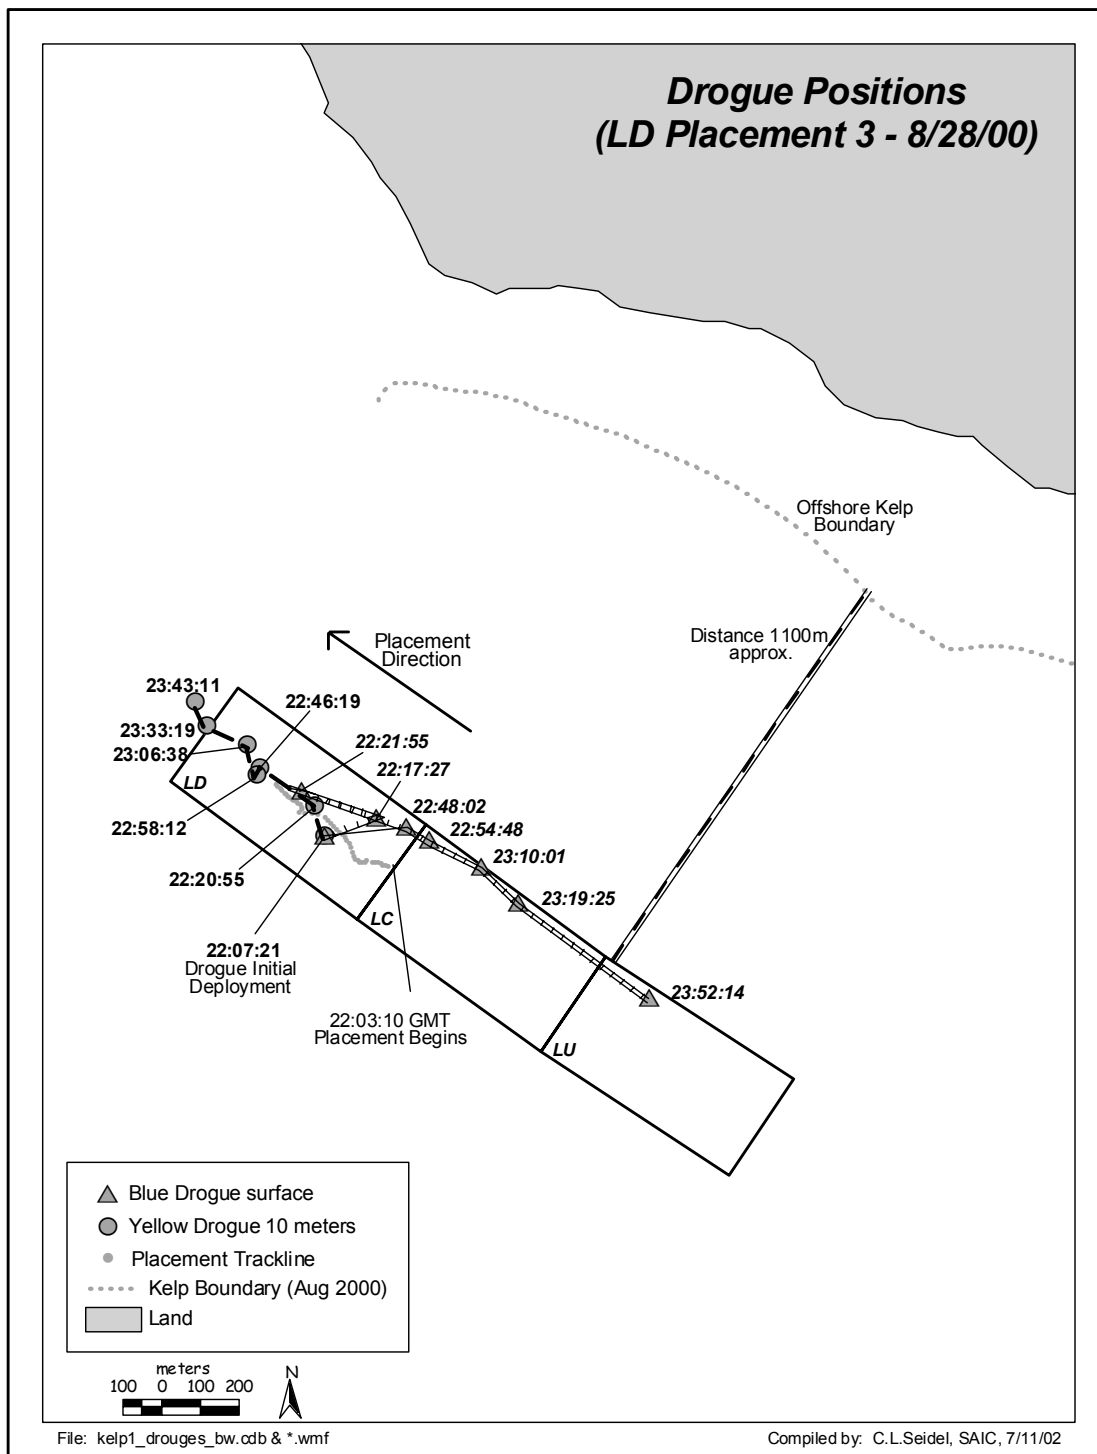
Figure 8.2-2. Map of Cells LD, LC and LU indicating trajectories of two drogues during water quality monitoring of near-surface plumes during spreading placement Event 3 in Cell LD on August 28, 2000.

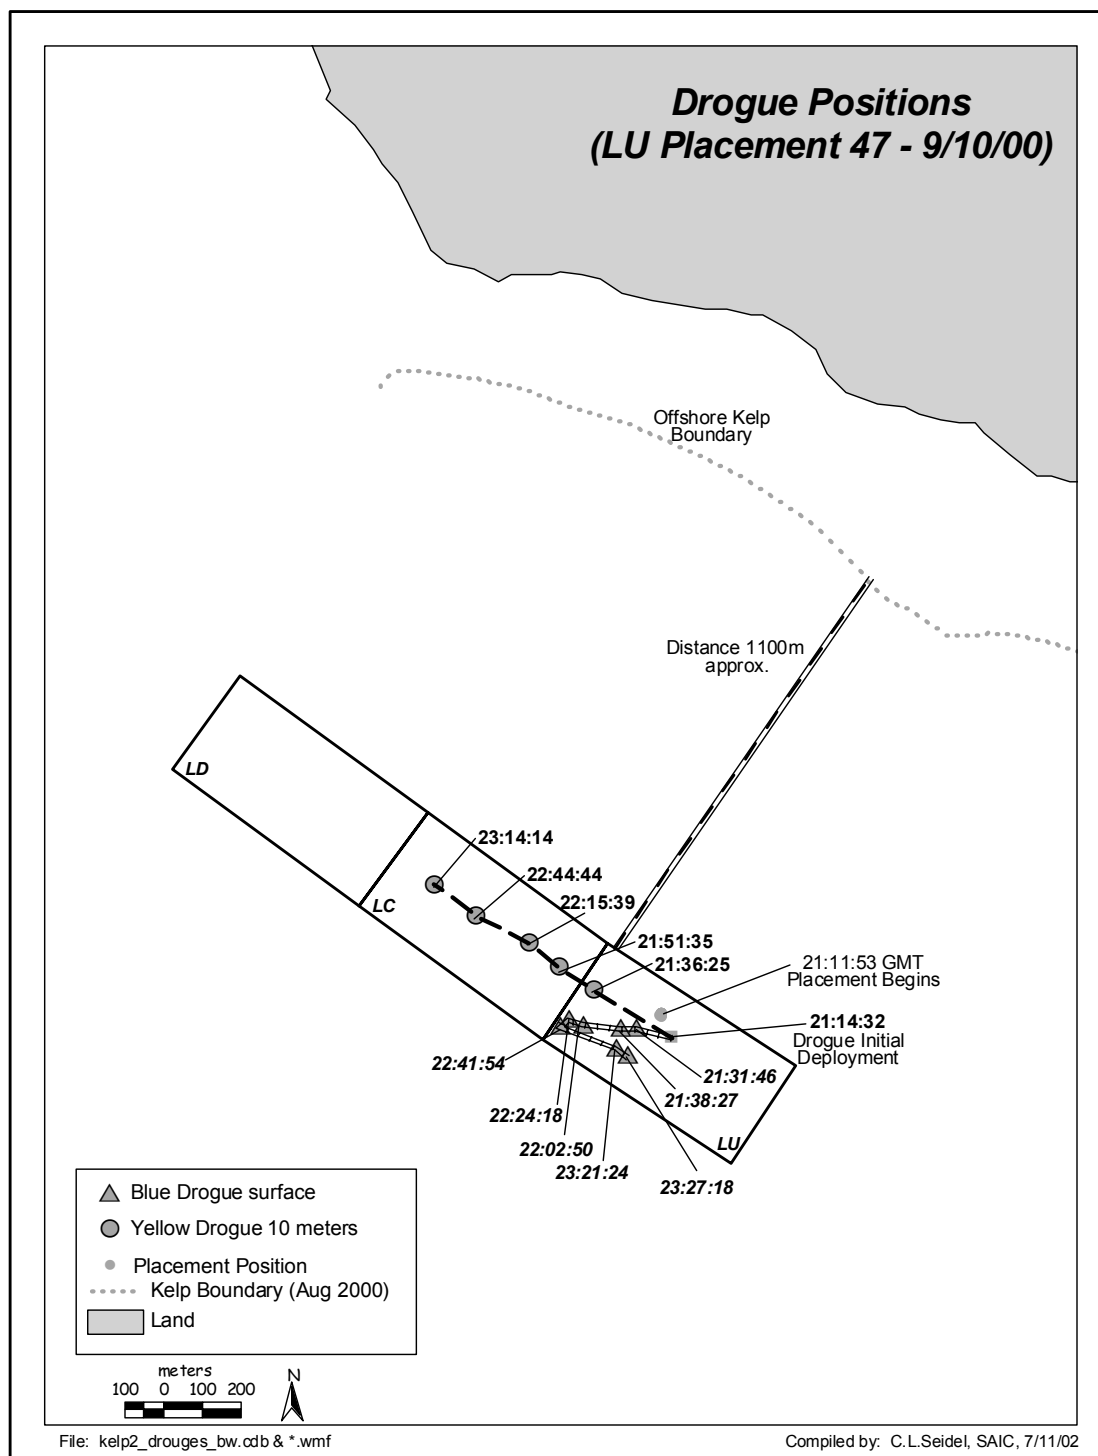
Figure 8.2-3. Map of Cells LD, LC and LU indicating trajectories of two drogues during water quality monitoring of near-surface plumes during conventional placement Event 47 in Cell LU on September 10, 2000.

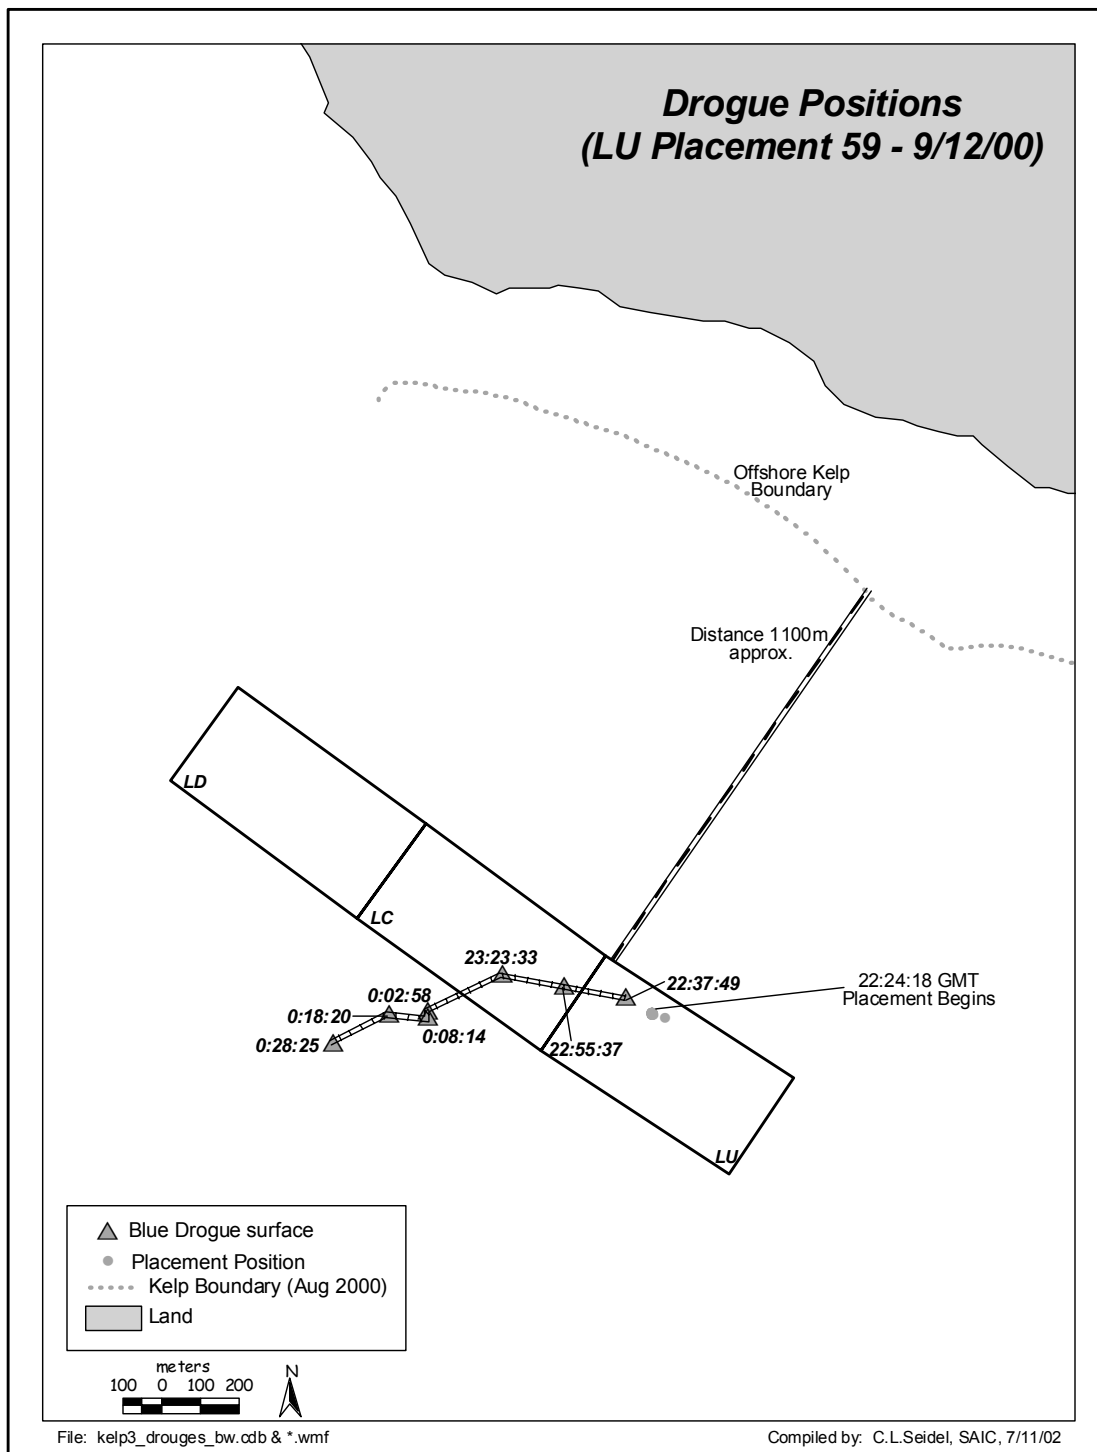
Figure 8.2-4. Map of Cells LD, LC and LU indicating the trajectory of the surface drogue during water quality monitoring of near-surface plumes during conventional placement Event 59 in Cell LU on September 12, 2000.

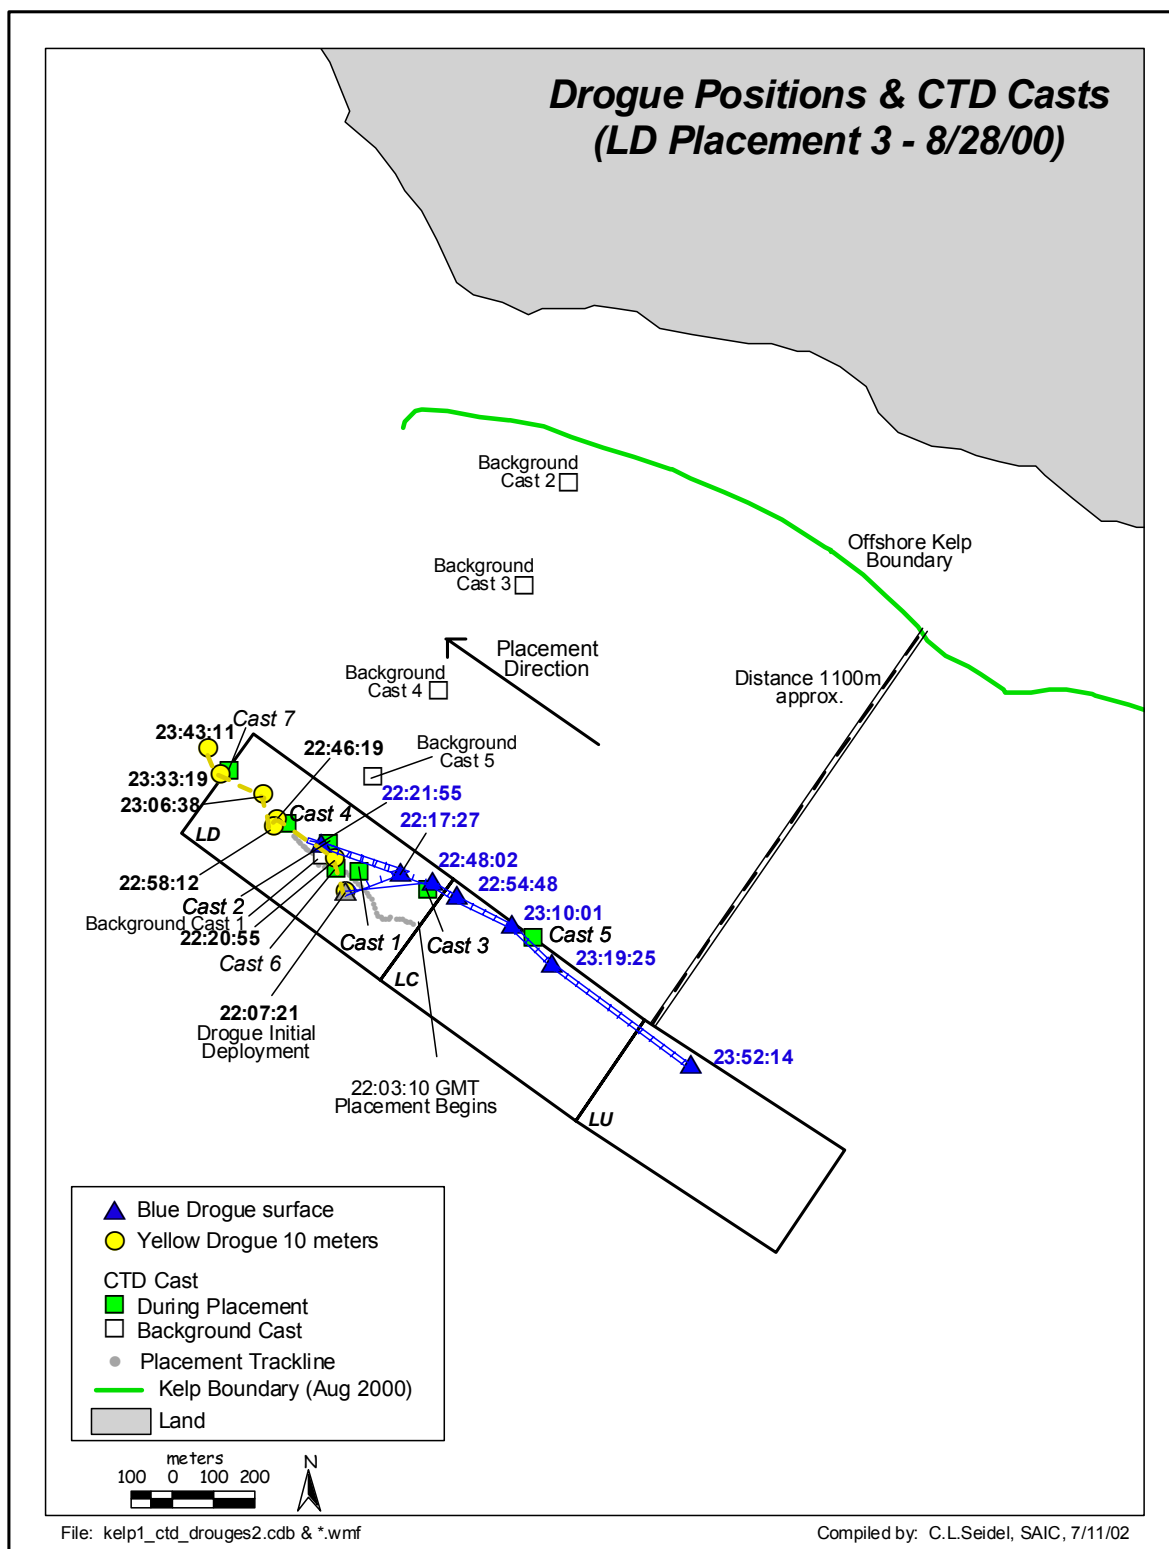
Figure 8.3-1. Map of Cell LD indicating drogue trajectories and CTD stations during cap spreading Event 3 on August 28, 2000.

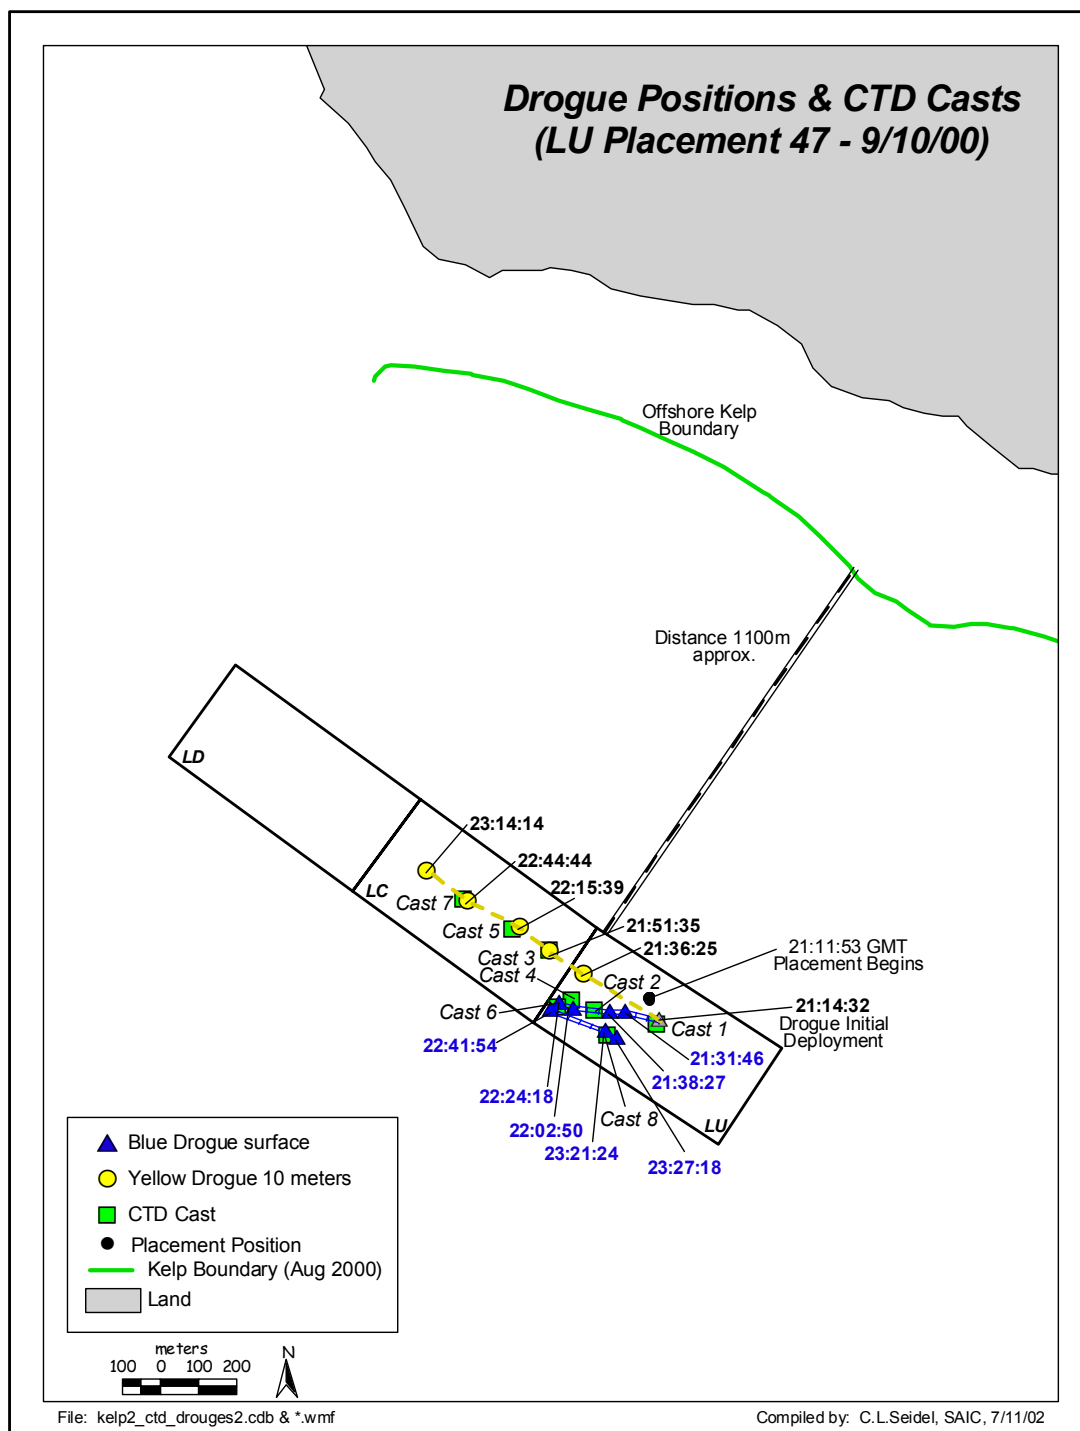
Figure 8.3-4. Map of Cell LU indicating drogue trajectories and CTD stations during conventional cap placement Event 47 on September 10, 2000.

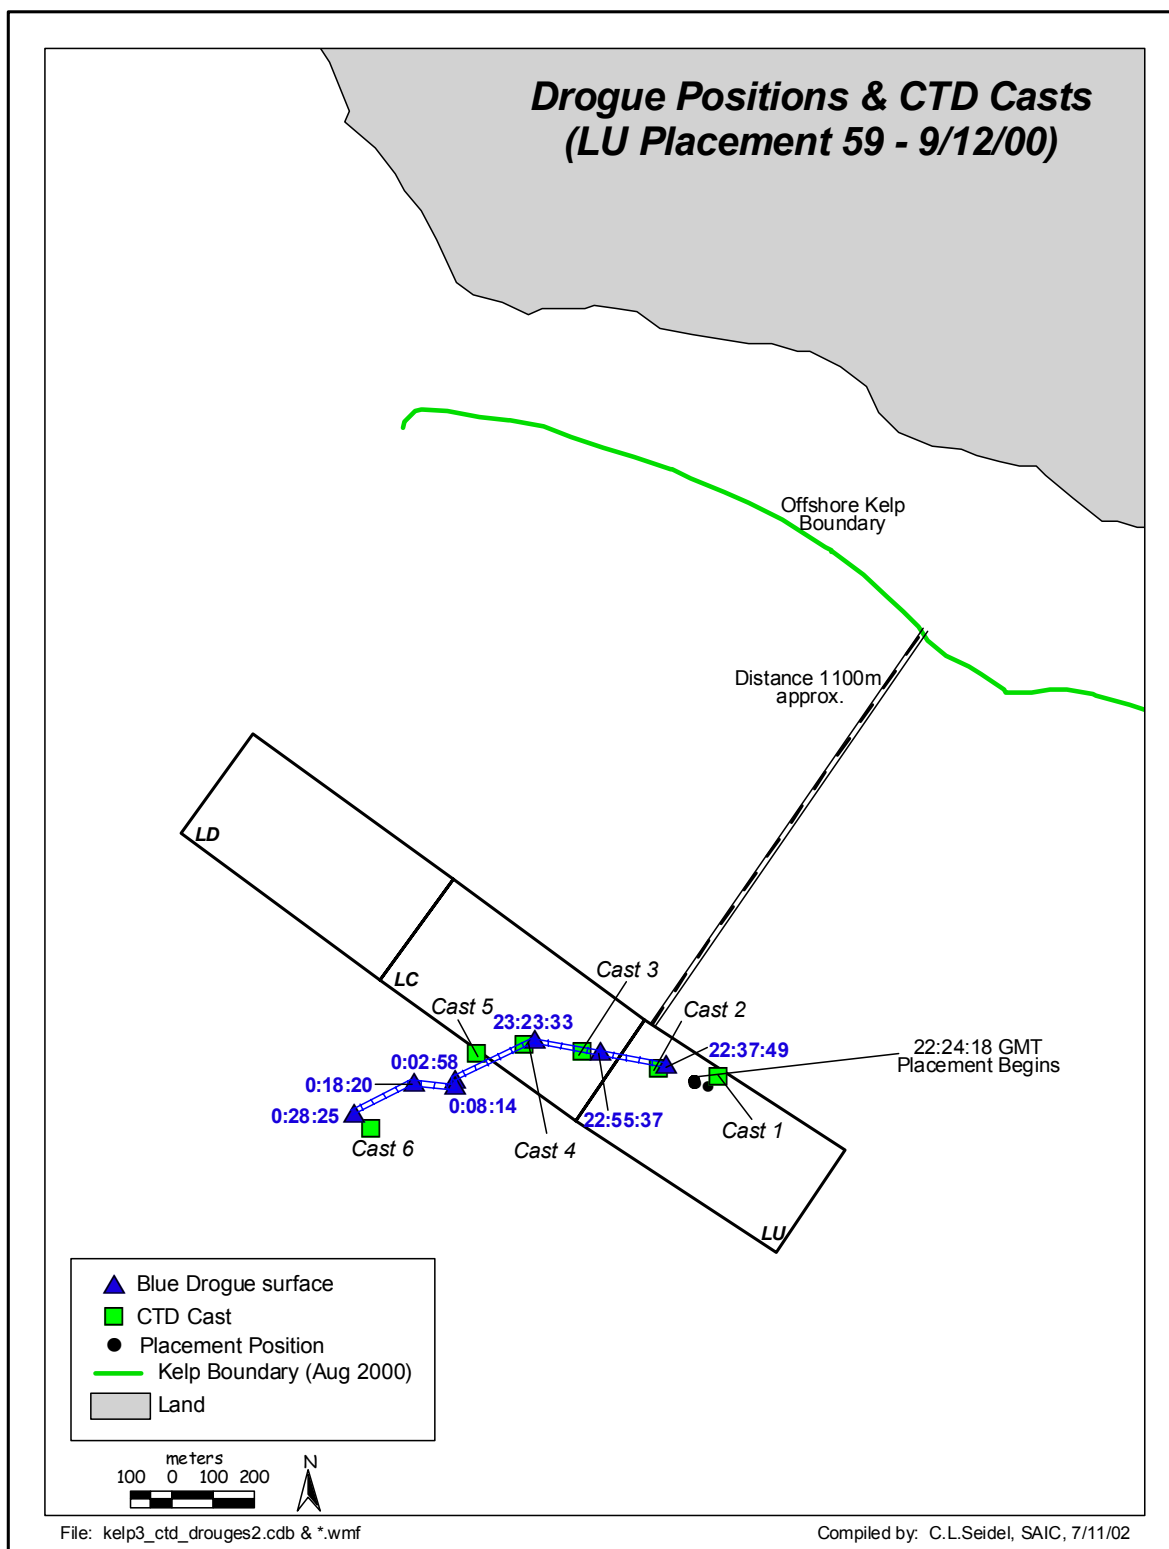
Figure 8.3-8. Map of Cell LU indicating drogue trajectories and CTD stations during conventional cap placement Event 59 on September 12, 2000.

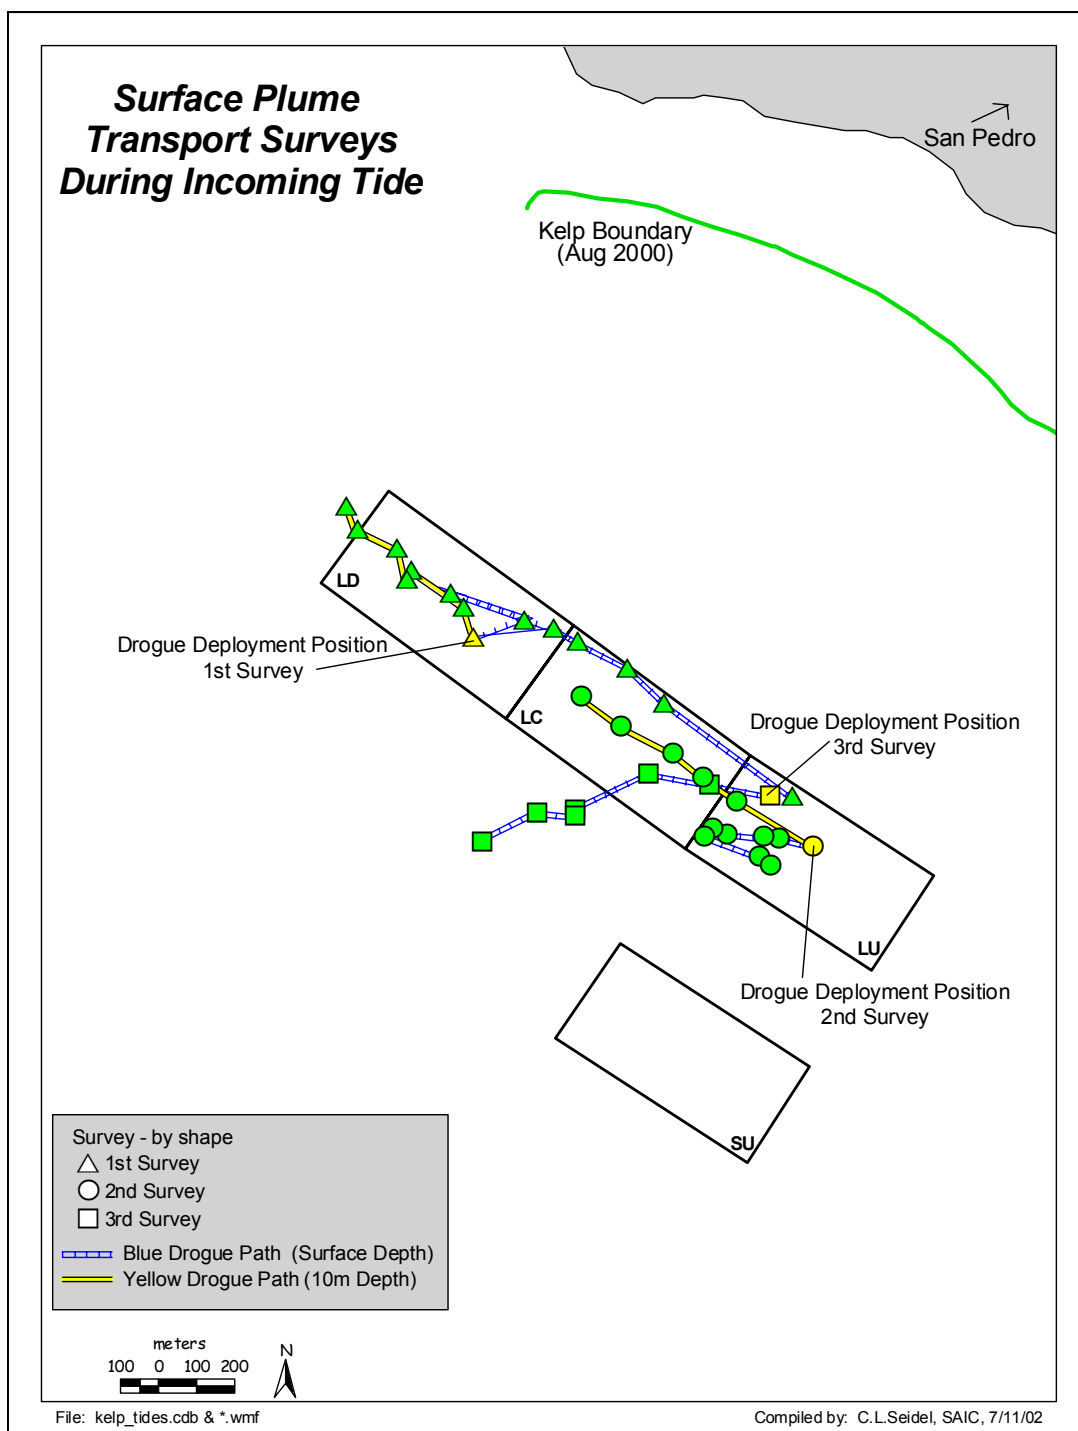
Figure 8.3-13. Map of Cells LD and LU indicating trajectories of drogues deployed during monitoring of near-surface plumes during three cap placement events. For each study, drogues were deployed within 30 min of the time of local high water to correspond with the beginning of the incoming tide.
